Repeatability and precision of different static deflection measurements on a real bridge-part under outdoor conditions in view of damage detection

Tanja Kebig¹, Viet-Ha Nguyen¹, Michél Bender², Markus Schäfer¹, Stefan Maas¹

KEY WORDS: bridge inspection; reference state; laser-based measuring system; displacement transducer-based measuring system.

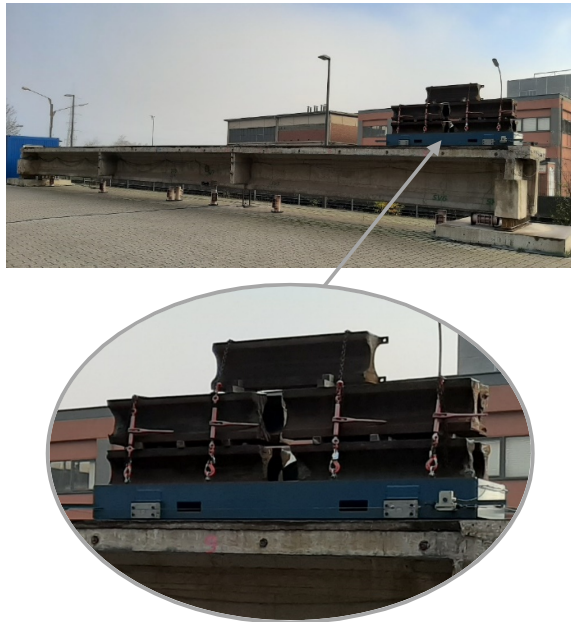
The tested beam was part of a real bridge in Mersch / Luxembourg. It was built in 1957 and demolished in 2016 due to safety concerns and replaced by a steel bridge. The initial bridge was 256 m long and consisted of nine fields with spans between 25.8 m and 47.5 m. During the old bridge's demolition, one of the prestressed T-beams was transported to University of Luxembourg Campus Belval in Esch-sur-Alzette. It had a length of 25.7 m, a width of 1.9 m and a height of around 1.4 m. Due to the new casted foundations and bearings, bridge plate's upper edge was approximately 2.1 m above ground. Figure 1 displays the whole test setup with the moving load.

Figure 1: Prestressed concrete beam with moving load

A load of approximately 8.8 t was used for the static loading tests. The load consisted of a trolley with nine steel beam blanks (see Figure 1). Figure 8 shows the two states of static tests:

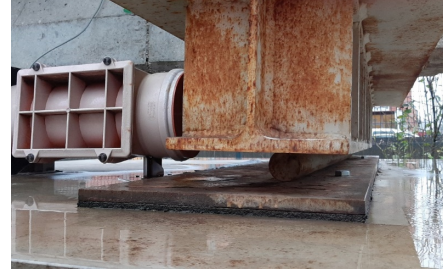
A fixed and a movable bearing supported the test beam. In a previous research project's test setup, the movable bearing was designed by using grease between two steel plates [6]. During these tests, stick-slip effects occurred due to the friction between the steel plates. Here, the impact of the movable bearing type was tested with 3 different types of movable bearing: round bar, mageba Lasto® Flonpad and steel plates with grease. The different movable bearings were exchangeable at any time with little effort and so it was possible to assess the impact of the bearing type and its friction in different seasons. But here, the focus is on the comparison of different displacement measuring systems. Therefore, only the setup with the round bar, shown in Figure 2, is presented.

Figure 2: Movable bearing with a round bar

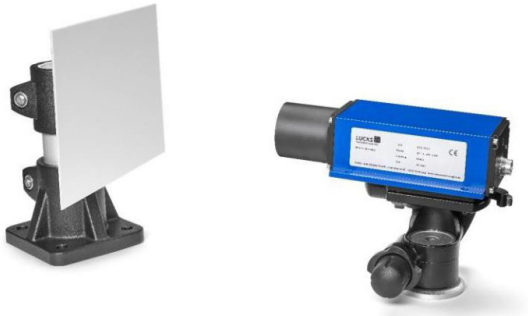
In January 2020, an additional measurement system was installed on the beam, i.e. the laser-based measurement system supplied by Lucks Technologies [7]. The general setup is shown in Figure 5. This system aims to record the movements of the bridge via horizontal distance measurements. For this test setup, it consisted of two laser sensors (L1 and L2), two reflector panels (RPs), a central processing unit (CPU) and two temperature sensors. The two lasers (class 2) were mounted on the concrete foundation on the fixed bearing side (Figure 6). These laser locations were defined as fixed points.

Figure 5: Laser-based measurement system of Lucks Technologies [7]

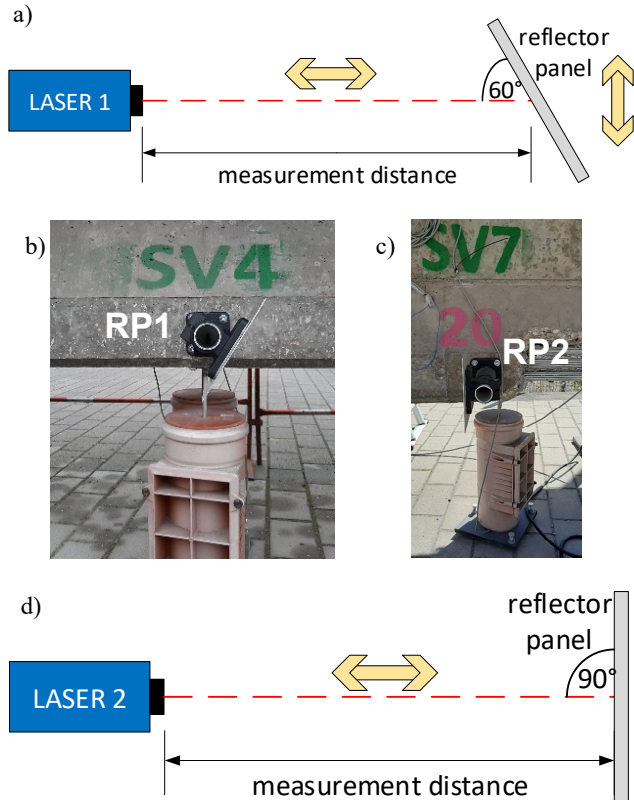
The reflector panels were installed on the beam, forming the movable part of the measuring system (target). The targets were mounted at different angles with respect to the laser beam (Figure 7). Whenever the bridge was moving up or down, the measuring distance changed due to the inclination of the RPs. The lasers can detect a measuring distance between 1 and 100 m with a maximum sampling rate of 50 Hz [7]. For the test beam, the measured distances were between 11 and 14 m and the sample rate was set to 10 Hz.

The reflector panel of laser 1 (RP1) was installed at an angle of 60° between the panel and the incident laser beam (Figure 7 a) and b)). Due to the inclined reflector panel, it was possible to measure the vertical deflection indirectly. The measured distance thus included a horizontal and vertical displacement component. Separation into the individual components was only possible by measuring a second purely horizontal measurement distance with L2, as shown in Figure 7c) and d). The calculated deflection of L1 is compared to the displacement transducer data of SV4.

Figure 7: a), b) Laser 1 with reflector panel of 60° , c), d) Laser 2 with reflector panel of 90°

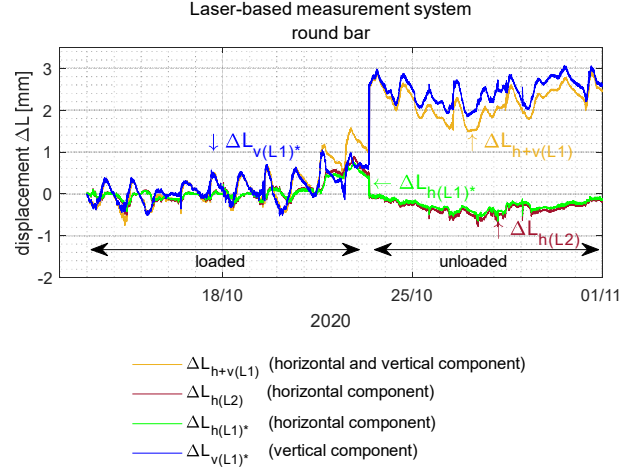
To compare the laser data, the measured values of L2 were converted to the measuring point of L1 with Eq. (1). Equation (1) is based on the assumption that the bridge moved linearly in the longitudinal horizontal direction starting from 0 at the fixed bearing to a maximum at the movable bearing. The result of this calculation is shown in Figure 14 by the green line $\Delta L_{h(L1)*}$. The blue line shows the vertical displacement component $\Delta L_{v(L1)*}$ calculated with Eq. (4).

Figure 14: Different displacement components in the middle of the beam, 13/10-31/10/2020

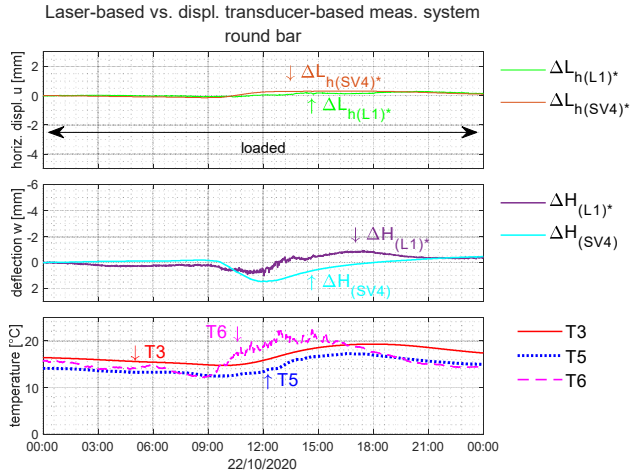
Figure 16 shows a one-day measurement in detail. October 22, 2020, was a sunny day and the temperatures varied considerably. The measurements were set to zero at midnight. The deflection values of SV4 followed the concrete

temperature T3, while L1 was closer to the air temperature (T6). The largest deviations occurred between 11:00 to 19:00, where a deviation up to -1.63 mm was observed. The smallest difference during this day was +0.55 mm.

Figure 16: Laser vs. displacement transducer – deflection and displacement in the middle of the beam, 22/10/2020

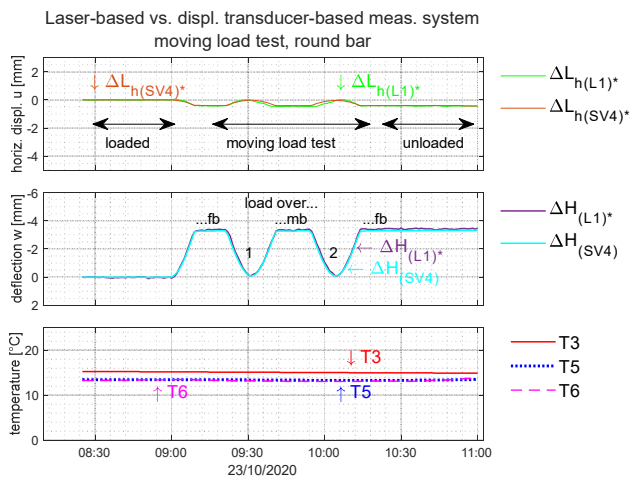
The bridge's deformations during a moving load test are shown in Figure 17, where the different crossings are numbered in the middle chart. No.1 shows the first crossing of the bridge from fixed to movable bearing and no. 2 the crossing in the opposite direction. The temperatures during this test phase were quite constant. The deviation of the deflection w was from -0.35 to 0.09 mm. Two additional measurement points were selected and evaluated. In the first crossing, the trolley reached the center of the bridge at 09:31 AM and in the second crossing at 10:04 AM. The relative error for the horizontal displacement was -4.6 % [-12.0 %] and for the deflection -3.3 % [-2.8 %] at 09:31 AM [at 10:04 AM].

Figure 17: Laser vs. displacement transducer – deflection and displacement in the middle of the beam, moving load test, 23/10/2020
