# Dynamic damage identification using linear and nonlinear testing methods on a two-span prestressed concrete bridge

**ABSTRACT:** In this paper dynamic testing methods on a two span prestressed concrete bridge are examined to evaluate the ability on damage assessment on civil engineering structures in situ. The testing methods are based on analysing modal parameters, i.e. the eigenfrequencies and the modeshapes, as well as the calculation of the corresponding flexibility matrix. Variations on them are shown for different damage states, realised by continuously cutting tendons and loading the bridge with an experimental mass of 245t. Moreover, the evaluation of nonlinear parameters as the amplitude dependency of the eigenfrequencies is also presented. For the different damage states cracks are noticed at the different cutting sections. As nonlinear parameter and the modeshapes do not retrieve clear indications on the damage, the changes of the eigenfrequencies and the flexibility matrices demonstrate, in contrast, clearly the capability on damage assessment on the investigated object.

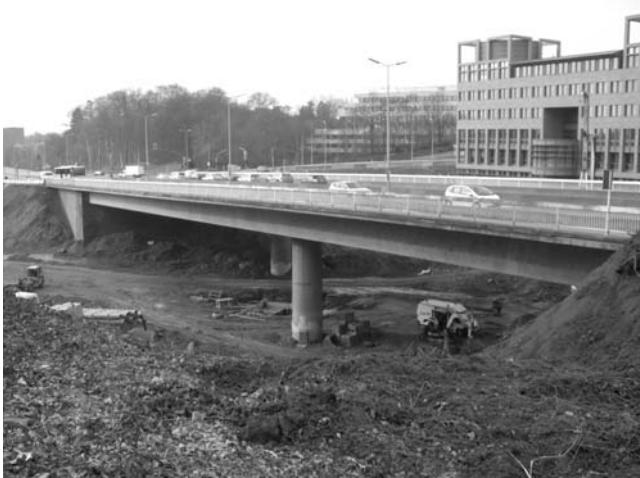
Figure 1. Picture of the bridge in winter 2010.

The investigated bridge (Fig. 1), which is called Champangshiel, was built from 1965 to 1966 and connects the centre of Luxembourg with the district Kirchberg. It is a two span prestressed concrete bridge with different span length (Fig. 2). The length of the bridge is 102 m, divided into two fields of 65 m and 37 m in length. The superstructure of the bridge is a prestressed box girder with 32 parabolic, 24 upper straight lined and 20 lower straight lined subsequently injected tendons (Figs 3-4). The roadbed has a width of 12.5 m and the box girder of 6.5 m with a height of 2.62 m, as illustrated on Figure 3. The bridge is made of concrete B450 and the tendons of Steel ASTM A.416 57T. The superstructure is supported by two abutments and one column made of reinforced concrete. At the west abutment (abutment of the large field) is a mobile bearing made of a steel roll, whereas on the east abutment, the bearing is fixed. Between the superstructure and the substructure over the pylon an elastomeric support is placed. In 1987, 56 external prestressed steel cables were added into the box girder of the large field due to additional safety (Figs 3-4) (Scherbaum et al. 2011).

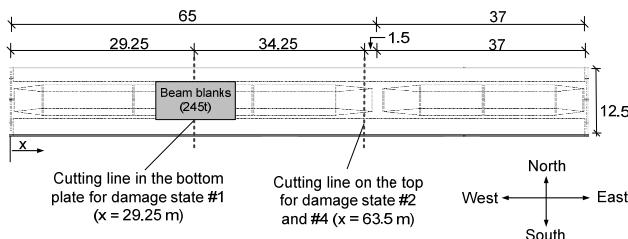
Figure 2. Longitudinal Section of the bridge with the cutting sections and the position of the experimental mass.

In order to validate the presented testing methods for damage assessment, tests are conducted for different damage scenarios. Table 1 summarises the different damage states (intact #0 to the most damaged #4) by continuously cutting a defined number of tendons at two different sections of the bridge, as illustrated on Figure 2.

Table 1. Description of the damage scenarios according to the cutting sections shown on Figure 2.

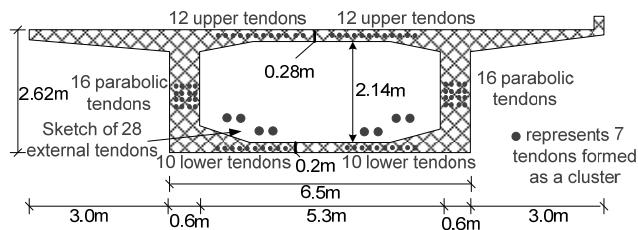
Figure 3. Schematic cross section of the bridge with all the tendons.

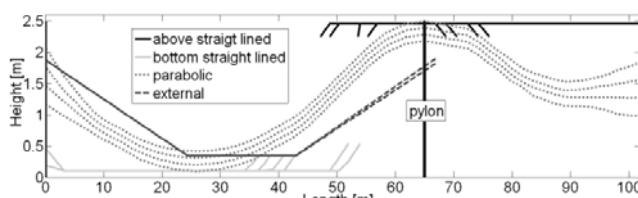
Figure 4. Longitudinal section of the bridge showing only the tendons.

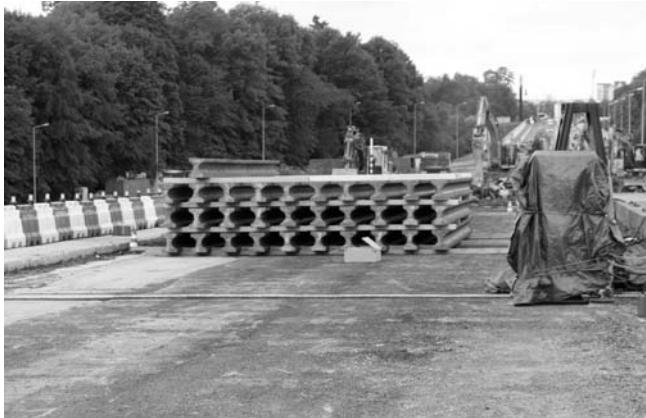
Figure 6. Experimental mass, after loading with 31 of 38 beam blanks.

These damage states are crucial to evaluate the sensitivity of the test results according the severity of introduced damage and formation of cracks. This is achieved by firstly cutting a defined number of tendons and secondly by loading the bridge with an additional experimental mass of 245 t, consisting of 38 beam blanks from ArcelorMittal (Fig. 6). One has to add, that for each damage state, except for #4, the bridge is loaded with the experimental mass for static and additional dynamic measurements (data not shown).

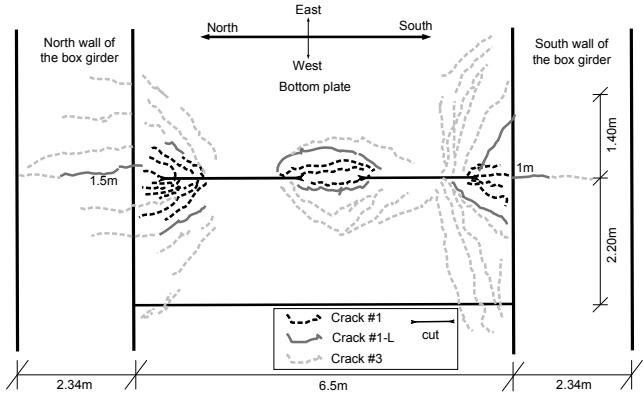
Figure 7. Schematic view of the crack appearance at the bottom plate for the cutting line at  $x=29.25$  m.

Description	Cracks
#1	Shear cracks due to the new anchorage points of the prestressed cables by cutting the lower 20 straight lined prestressed cables (black cracks, dashed line on Figure 7)
#1-loaded	#1 + one crack in the girder at the north side up to 1.5m from the bottom line (dark grey cracks, solid line on Figure 7) and 1m on the south side at the cutting line of the lower 20 straight lined tendons
#3	#1-L + growing of the existing cracks and formation of new cracks at 0.45L (grey cracks, dashed line on Figure 7) + small crack between the holes on the upper side with loading (Fig. 8).
#4	#3 + crack above the pylon (grey cracks, solid line on Figure 7 and Figure 8)

To compare the different damage states the flexibility matrices (only the sum for all 7 modes) of all the scenarios are presented on Figure 27. Variations according the damage can clearly be seen. Here around transducer position 15, where the highest damage occurred (cracks on Figure 7) the biggest changes are noticed. Damage state #4 shows the highest value concluding to the biggest loss in stiff-

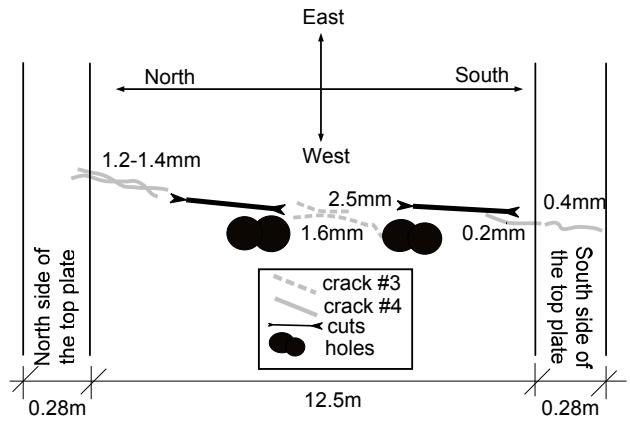
Figure 8. Schematic view of the crack appearance at the top plate for the cutting line at  $x=63.5$  m.

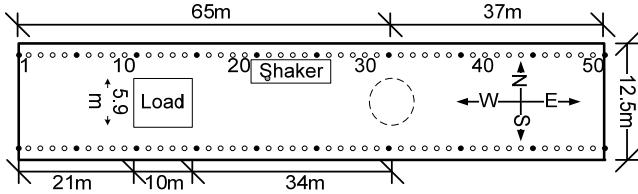
Figure 9. Experimental setup for the dynamic testing methods: Black circles: the position of the accelerometers for the coarse measurement grid. White circles: the additional positions for the dense measurement grid.

by placing the transducers on each position in white and black on Figure 9. They are shifted five times of about 2 m ( $5*20=100$  positions) to capture the movements at all presented positions, needed to obtain proper values to calculate the modeshapes. For evaluating and visualisation of these, each transducer position is numbered, beginning in the west with 1 to 50 in the east. In this paper, exclusively the Northern line is discussed.

The modeshapes of all the evaluated eigenmodes shown on Figure 10 are presented in this section. They are, as already introduced in the experimental part, captured by a dense measurement grid, spaced at 2 m apart from each transducer position (Fig. 9). In order to compare each modeshape from all the damage states to the intact states, each mode is normalised to Unit Modal Mass (UMM). On Figure 18 the modeshape for the first eigenmode B1 is displayed. For this it is difficult to retrieve any information out of the presented curves. The changes due to damage are very small and hard to identify.

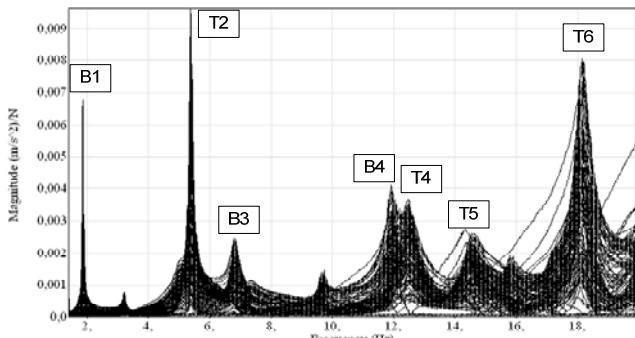
Figure 10. Frequency response functions of the intact state for the dense measurement grid.

Below the test results for the different measurement series are presented with first the eigenfrequencies, followed by the evaluation of the modeshapes as well as the corresponding calculations of the flexibility matrices and their changes for the different damage states. For this, one has to add that only the predominant modes are presented, shown on Figure 10, illustrating the frequency response functions for the intact state. These eigenfrequencies are also found for all other damage states and are named henceforth B1, T2, B3, B4, T4, T5 and T6, where B stands for bending and T for torsional modes.

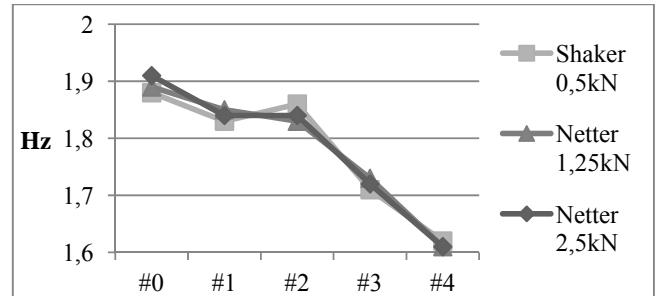
Figure 11. First eigenfrequencies (B1) for the different damage states and different excitation force amplitudes.

As examples of the changes of the eigenfrequencies only the first bending mode, named B1, the second torsional mode (T2) and the fourth bending mode (B4) are presented in the following. Regarding the first eigenfrequency on Figure 11, one recognises a drastic decrease according the damage states. Here for damage state #1 a diminishing of 3% is identified compared to the intact state #0. The reason is the appearance of a first crack in the bottom plate of the bridge yielding a loss in stiffness. Further, when cutting 8 of the above tendons, i.e. 12.6% of the tendons in the top plate for this damage state #2 (Fig. 5b), no crucial additional cracks are observed. Afterwards, for damage state #3 and #4, when cutting the external and 40% of the above tendons (Figs 5c, d) existing crack expand and more cracks occurred (Fig. 7), marked by a decrease of the eigenfrequency by 10% and up to 18% for damage state #3 and #4 respectively, presented on Figure 12.

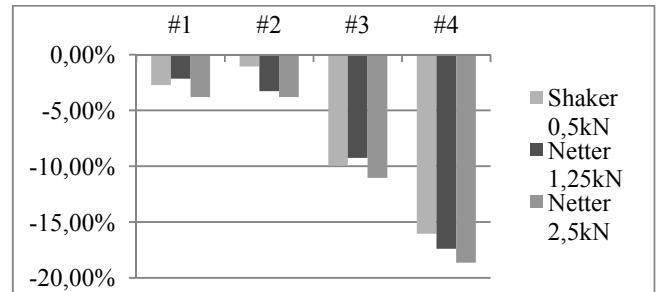
Figure 12. Percentage decrease of the first eigenfrequencies (B1) for the different damage states and excitation force amplitudes compared to the intact state #0.

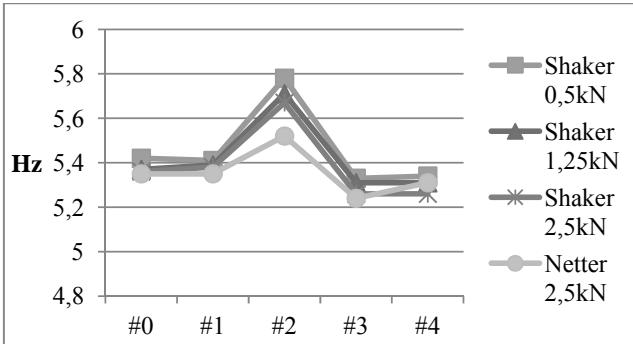
Figure 13. Second eigenfrequencies T2 for the different damage states and excitation force amplitudes.

In contrast, the changes of the eigenfrequencies of the second torsional mode T2 do not correlate with the damage, illustrated on Figures 13-14. Here no information according the severity on the damage can be made and the increase in scenario #2 is not understood.

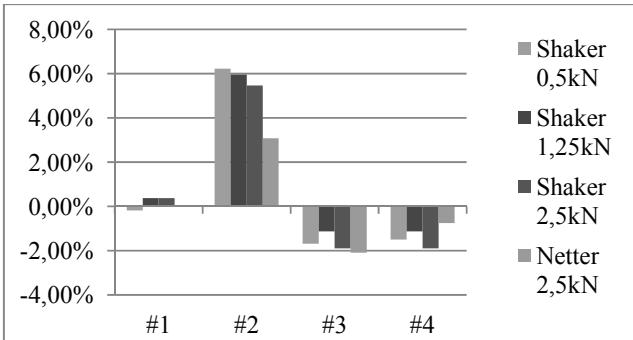
Figure 14. Percentage decrease of the second eigenfrequencies (T2) for the different damage states and excitation force amplitudes compared to the intact state #0.

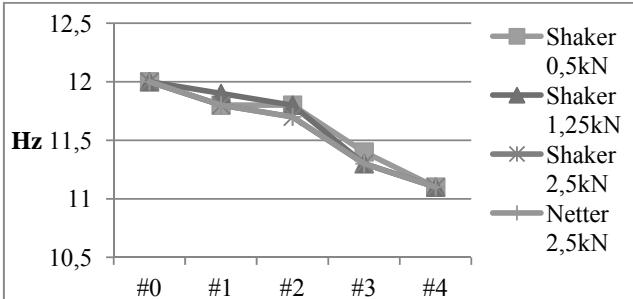
Figure 15. Fourth eigenfrequencies B4 for the different damage states and excitation force amplitudes.

On the contrary, the eigenfrequencies of the fourth bending mode (B4) on Figure 15 show also a significantly decrease due to damage. Here, for the evaluation of the percentage decrease on Figure 16 from damage state #1 to the intact state #0, variations up to 2% are recognised, increased to 6% for damage state #3 and to 8% for damage state #4.

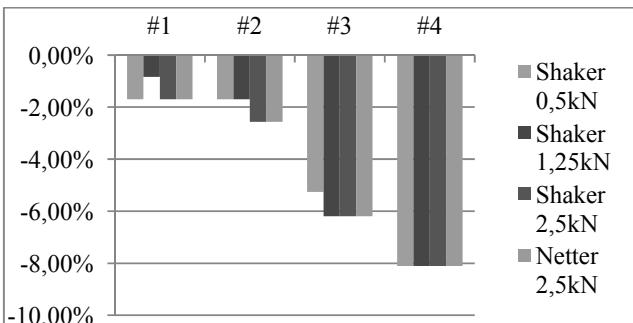
Figure 16. Percentage decrease of the fourth eigenfrequencies (B4) for the different damage states and excitation force amplitudes compared to the intact state #0.

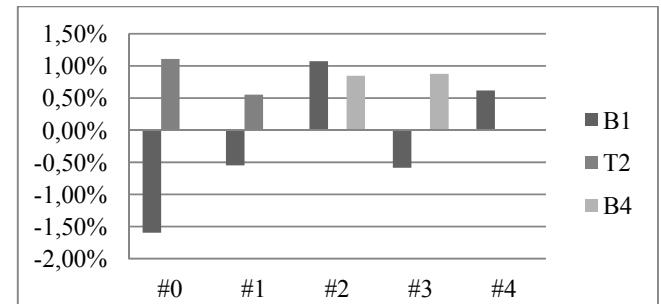
Figure 17. Excitation force amplitude dependency of the first eigenfrequency for Netter excitation of 2.5 kN to 0.5 kN from the shaker excitation.

Now, regarding the excitation force amplitude dependency of the eigenfrequencies for the presented examples, no pattern according the severity of the damage can be recognised, shown on Figure 17. For the first eigenfrequency B1, the amplitude dependency is around -1.5% for the intact state, meaning from an excitation force of 2.5 kN for the Netter excitation to 0.5 kN for the shaker excitation, increased to 1% for damage state #2 and varying from -0.5% to 0.5% for damage state #3 and #4. Neither for the second torsional mode T2 and fourth bending mode B4 an accurate pattern is noticed, making the amplitude dependency in this case not reliable for indications on damage.

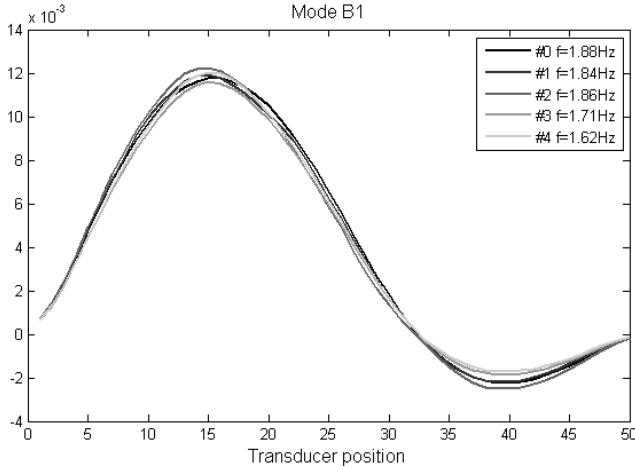
Figure 18. UMM-normalised modeshape of the first bending mode (B1) for the unloaded bridge.

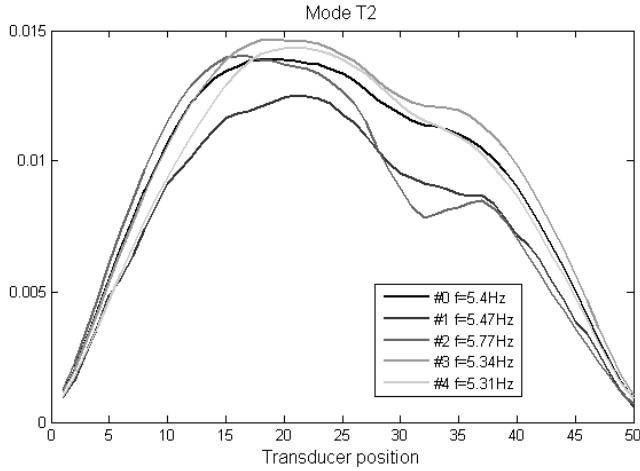
Figure 19. UMM-normalised modeshape of the second torsional (T2) mode for the unloaded bridge.

In contrast, looking at the second torsional mode T2 on Figure 19, big variations can be recognised, but cannot be associated to damage, as the amplitudes are either higher or lower the curve for the intact state. In addition, for the third bending mode B3 on Figure 20, the same behaviour is revealed. Neither here, especially between transducer positions 20 to 45, is a logical order of the curves recognised,

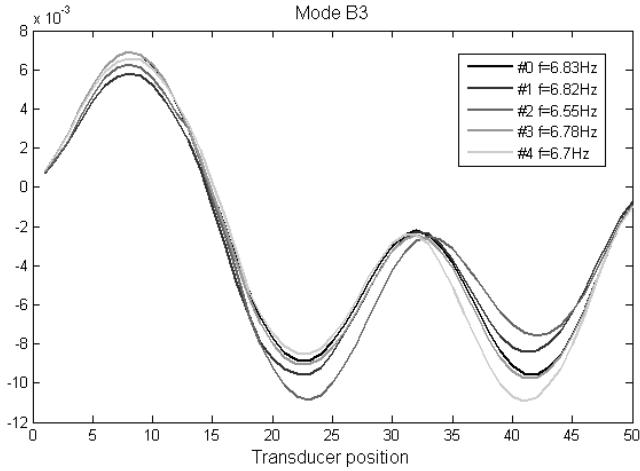
Figure 20. UMM-normalised modeshape of the third bending mode (B3) for the unloaded bridge.

concluding that no unique pattern can be identified for these two modes.

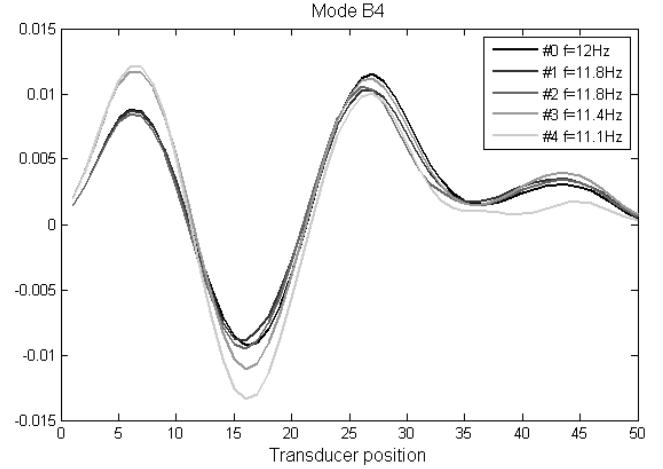
Figure 21. UMM-normalised modeshape of the fourth bending (B4) mode for the unloaded bridge.

However, for the fourth bending mode B4 on Figure 21, the fourth torsional mode T4 on Figure 22 and the fifth torsional mode T5 on Figure 23 varia-

tions to the intact state are clearly identifiable. Here, around transducer position 7 to 15 for B4 for example, differences according the increased damage are noticed. As well for the fourth torsional mode T4 the same behaviour can be discovered. For the fifth torsional mode T5, the changes are even more exposed; concluding that damage identification for these modes is possible.

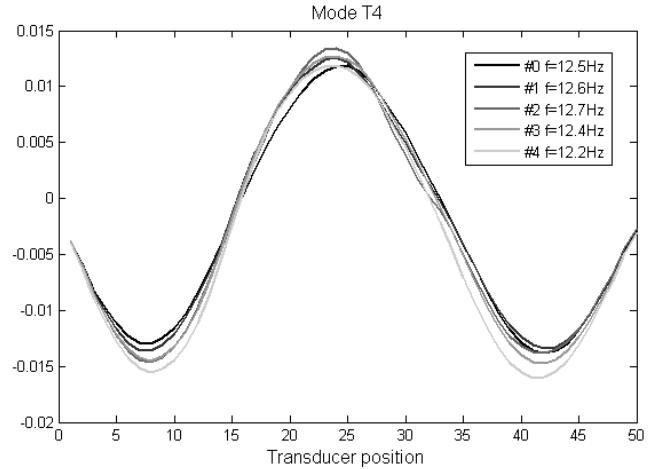
Figure 22. UMM-normalised modeshape of the fourth torsional mode (T4) for the unloaded bridge.

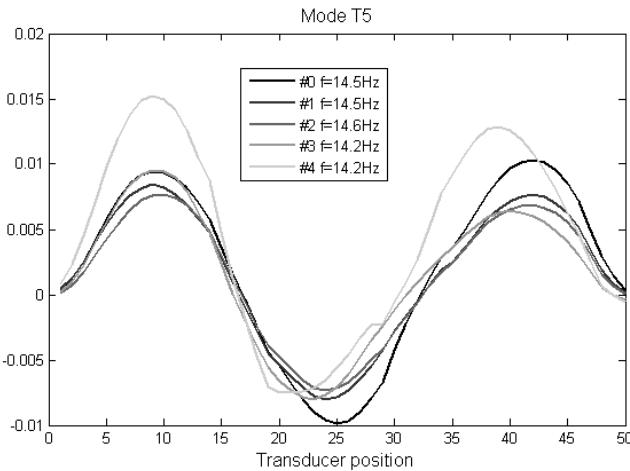
Figure 23. UMM-normalised modeshape of the fifth torsional mode (T5) for the unloaded bridge.

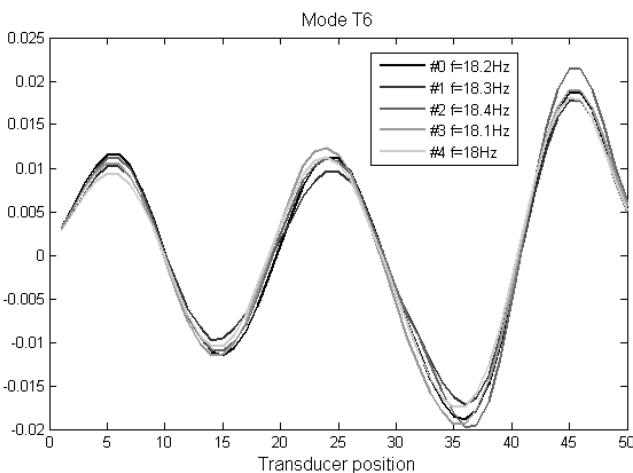
Figure 24. UMM-normalised modeshape of the sixth torsional mode (T6) for the unloaded bridge.

Finally, for the sixth torsional mode (T6), as for the first bending mode B1, no considerable changes due to damage are recognised. The mode seems not be as much affected by the changed stiffness as the other ones.

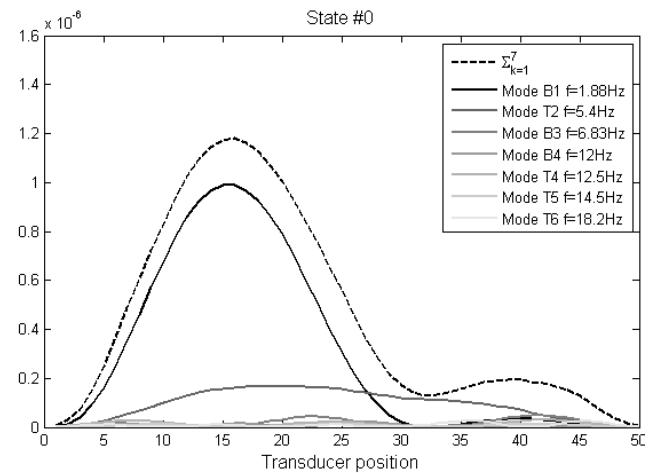
Figure 25. Modal decomposition of each of the seven modes and of their sum of the diagonal elements of the flexibility matrix for the intact state.

Figures 25-26 illustrate the diagonal elements of the flexibility matrices for the intact state #0 and damage state #4 in the modal decomposition mode, meaning that the flexibility matrix is calculated con-

sidering only one mode (solid lines). For better visualisation, the sum of all the 7 modes is presented also on the graphs (dashed line). Here, one can recognise that the flexibility matrix is determined already by the first two modes, i.e. the first bending mode B1 and the second torsional mode T2. This is due to the fact that according Equation 1 the UMM-modeshapes are divided by the square of the angular frequencies, which increase considerably for higher modes (from 1.8Hz to 18Hz) and, therefore, the impact of the higher modes diminishes in the calculation of the flexibility matrix.

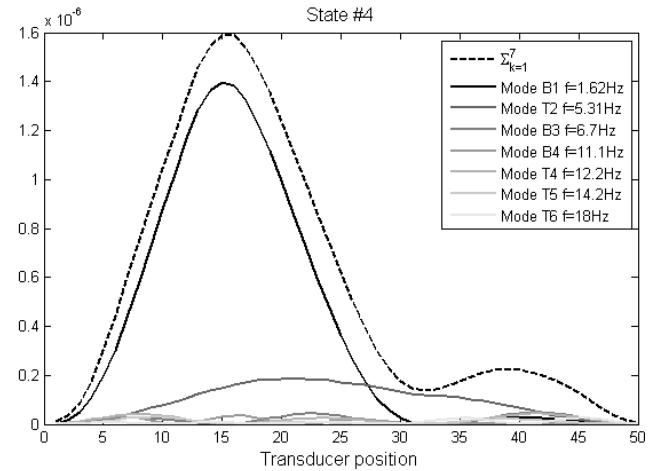
Figure 26. Modal decomposition of each of the seven modes and of their sum of the diagonal elements of the flexibility matrix for damage state #4.

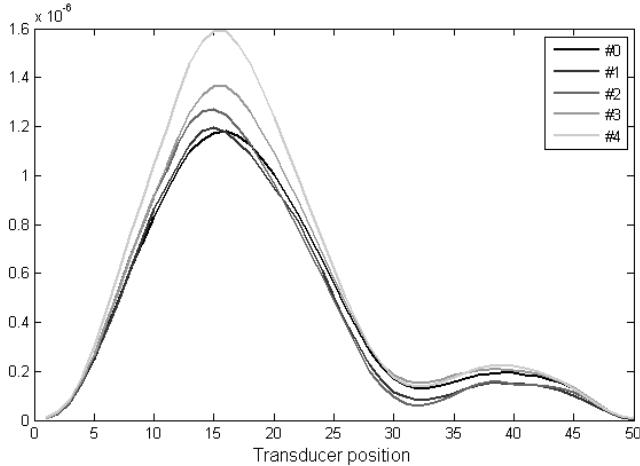
Figure 27. Diagonal elements of the flexibility matrices for the unloaded bridge.

ness, followed by damage state #3 and so forth. Hence, here the right order according the different damage states is identified and, moreover, localisation of damage becomes feasible.

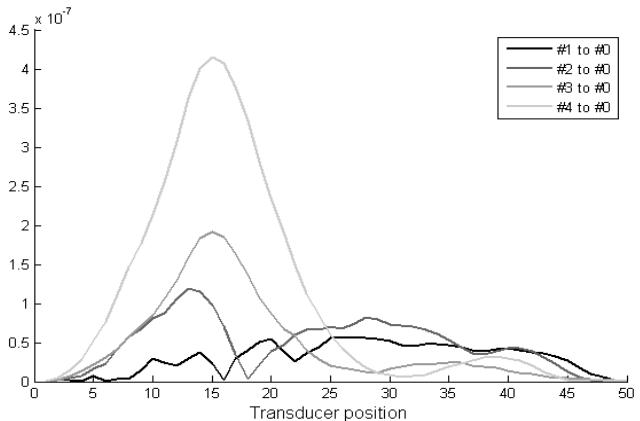
Figure 28. Difference of the diagonal elements  $\delta$  of the flexibility matrices for all damage states compared to the intact state #0.

Furthermore, for a better visualisation of the variations of the flexibility matrices, the following Figure 28 shows the differences of the diagonal elements of the flexibility matrices according Equation 2, in which  $d_{\#i}$  marks the diagonal elements in each flexibility matrix for the  $i$ -th damage state:

This is a similar technique used in literature (Pandey et al. 1995, Lenzen 2009) for better localisation of damage and presenting the changes of the flexibility matrices. Also here, one can see clear variations from one damage scenario to the other, as already observed on Figure 27. With increasing damage, compared to the intact state, the changes get evident, making the evaluation of the flexibility matrices a trustful indicator on the loss of stiffness, i.e. the formation of cracks.
