Experimental study on the flexural behaviour of demountable steel-concrete composite beams at room temperature and under fire exposure

P.S. Mora^a, A. Espinós^a, C. Odenbreit^b, M.L. Romero^{a,*},¹

ABSTRACT

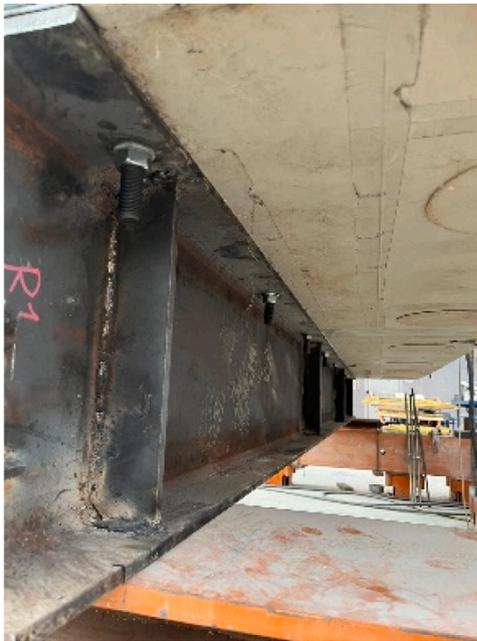
Fig. 8. Detail of steel beam web stiffeners.

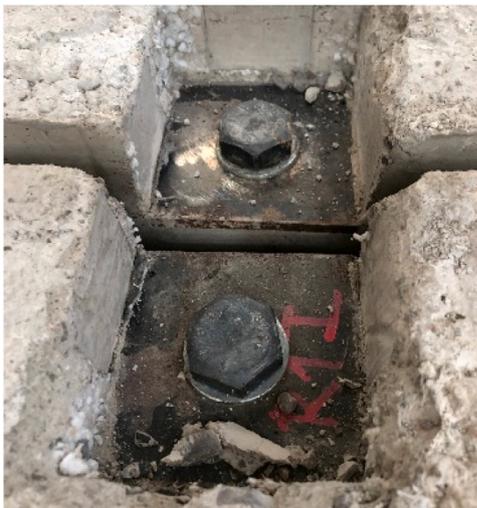
Fig. 9. Detail of P3 connectors seen from the top of the slab.

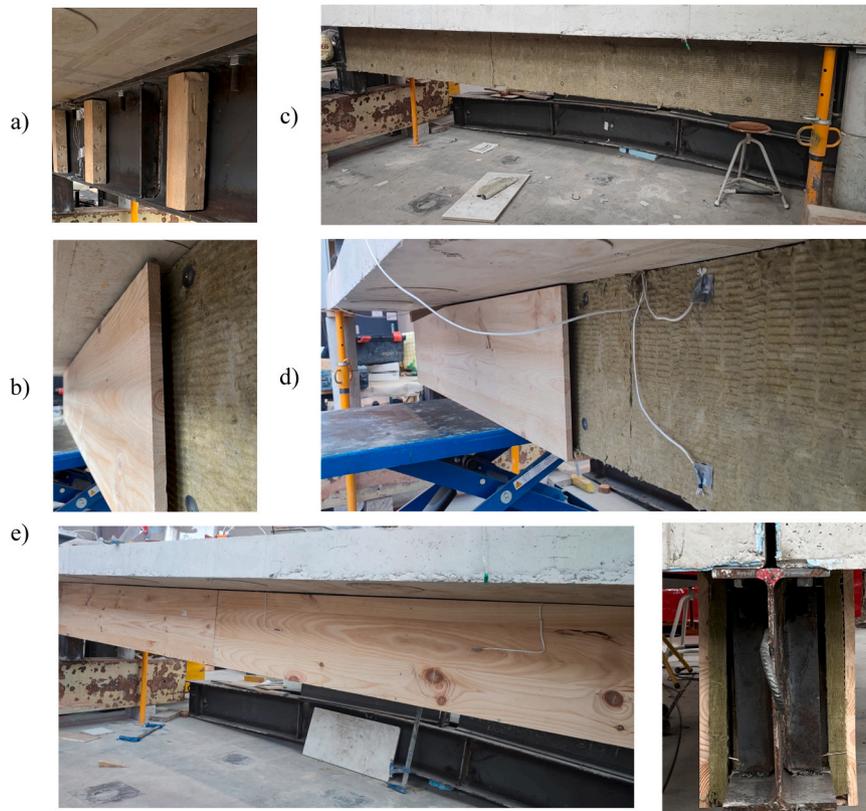
Fig. 10. Installation of the mineral wool insulation to protect the steel beam and finishing of the box protection with timber panels.

The installation of the fire protection system for the two beam specimens to be tested under fire conditions (FIREDUCE-FR-P3 and FIREDUCE-FR-P15) was performed in the following sequence (see details in Fig. 10):

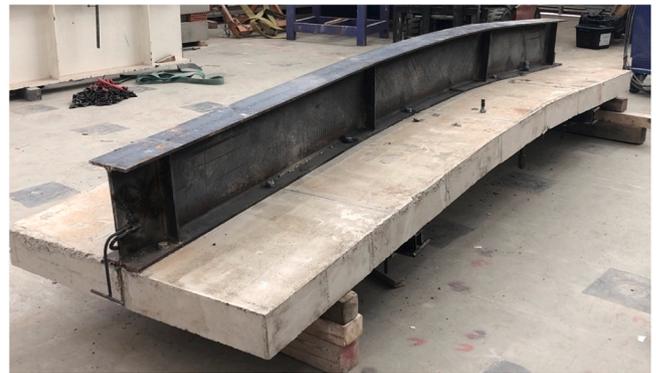
Fig. 15. State of one of the composite beams after room temperature test.

2.3.3.1. *Experimental observations.* The state of one of the beams after the room temperature test can be seen in Fig. 15, where it was positioned upside down to proceed to its disassembly. No evidence of shear failure of the bolts was observed. Some of them – the ones located closer to the beam ends – presented a higher level of deformation, but they were still in place with no signs of rupture. In turn, the bolts located at mid-span section did not suffer any plastic deformation and were easily screwed off. Although the demountability concept of the composite beams is conceived for serviceability (i.e. disassembly and reuse after service life), it was observed that the connection system still maintained the capability to be disassembled after ultimate failure, keeping the potential to detach the different parts and recycle the materials. Thus, considering that in service life the beams would not reach such deflection levels and in consequence the bolts would not experience significant

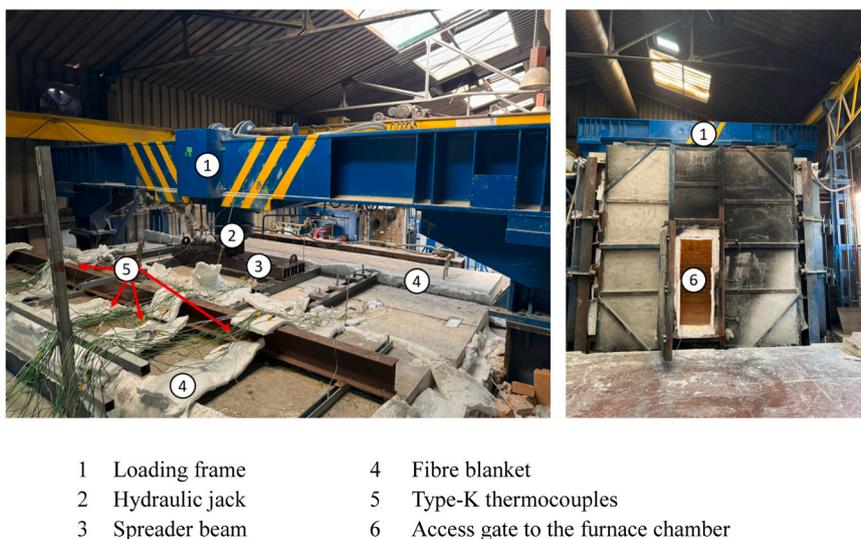
Fig. 21. Fire test setup (outer view of the gas furnace).

The beam fire tests were conducted at the facilities of AFITI, Arganda del Rey, Madrid (Spain). The beams were subjected to a standard fire test on a gas furnace, being placed at the top of the furnace chamber and supported at both ends, simulating a simply supported beam condition. All contact areas between the furnace walls/ceiling and the beam were conveniently sealed with fibre blanket, both inside and outside the furnace, to prevent heat escape. A general view of the fire test setup can be seen in Fig. 20 (inner view) and Fig. 21 (outer view).
